Avian Mortality at Solar Energy Facilities in Southern California: A Preliminary Analysis

Rebecca A. Kagan, Tabitha C. Viner, Pepper W. Trail, and Edgard O. Espinoza
National Fish and Wildlife Forensics Laboratory

Executive Summary

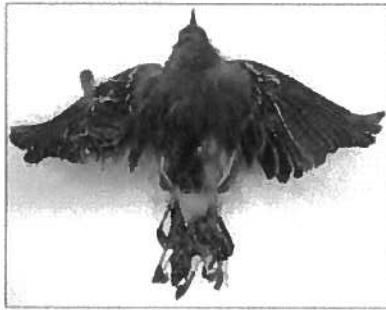
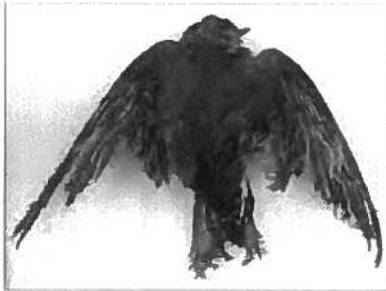
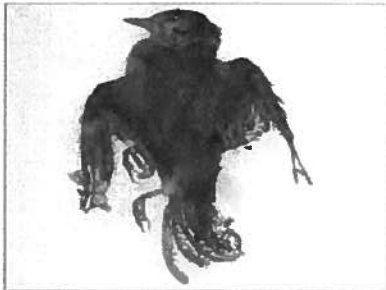
Birds with feather burns were graded based on the extent of the lesions. Grade 1 birds had curling of less than 50% of the flight feathers. Grade 2 birds had curling of 50% or more of the flight feathers. Grade 3 birds had curling and visible charring of contour feathers (Figure 1).

Figure 1: Three grades of flux injury based on extent and severity of burning. Grade 1 (top); Yellow-rumped Warbler with less than 50% of the flight feathers affected (note sparing of the yellow rump feathers). Grade 2 (middle); Northern Rough-winged Swallow initially found alive but unable to fly, with greater than 50% of the flight feathers affected. Grade 3 (bottom); MacGillivray's Warbler with charring of feathers around the head, neck, wings and tail.

Eight birds were assigned a feather damage Grade of 1 with curling of less than 50% of the flight feathers. Six of these had other evidence of acute trauma (75%). Five birds were Grade 2, including three birds that were found alive and died shortly afterwards. Of these birds, 2 (the birds found dead) also had evidence of acute trauma. Twenty-eight birds were Grade 3; with charring of body feathers. Of these birds, 21/28

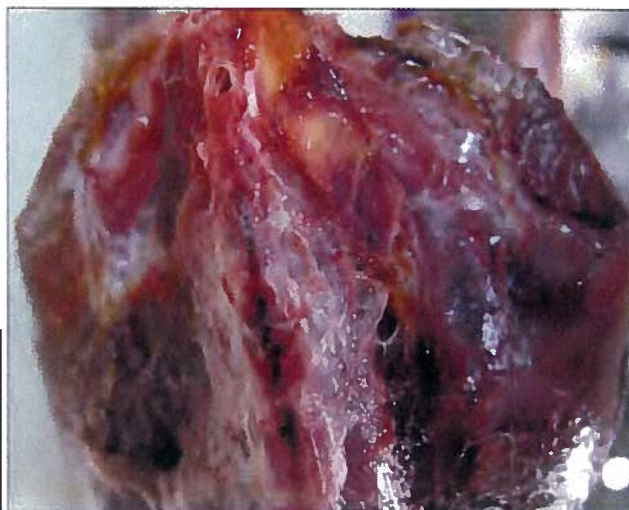
Blunt force impact trauma was determined to have been the cause of death for 19 Desert Sunlight birds including two Western Grebes (*Aechmophorus occidentalis*) and one each of 16 other species. Impact (blunt force) trauma is diagnosed by the presence of fractures and internal and/or external contusions. In particular, bruising around the legs, wings and chest are consistent with crash-landings while fractures of the head and/or neck are consistent with high-velocity, frontal impact (such as may result from impacting a mirror).

Predation was the immediate cause of death for 15 birds. Lesions supporting the finding of predation included decapitation or missing parts of the body with associated hemorrhage (9/15), and lacerations of the skin and pectoral muscles. Eight of the predated birds from Desert Sunlight were

Figure 2: Predation trauma (top) resulting in traumatic amputation of the head and neck (American Avocet) and impact trauma (bottom) causing bruising of the keel ridge of the sternum (Brown Pelican).

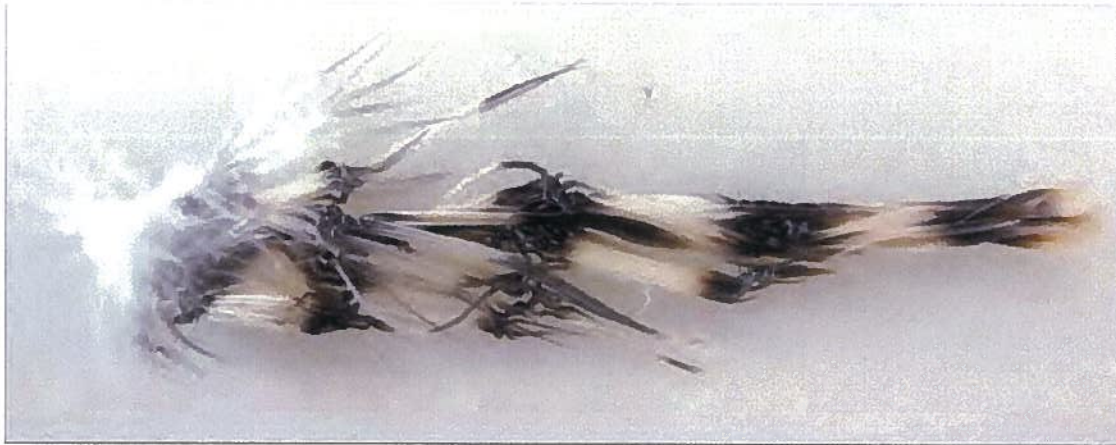
Figure 4: Feather from a Peregrine Falcon with Grade 2 solar flux injury. Note burning of dark feather bands with relative sparing of light bands.

Solar flux injury was identified as the cause of death in 47/141 birds. Solar flux burns manifested as feather curling, charring, melting and/or breakage and loss. Flight feathers of the tail and/or wings were invariably affected. Burns also tended to occur in one or more of the following areas: the sides of the body (axillae to pelvis), the dorsal coverts, the tops and/sides of the head and neck and the dorsal body wall (the back). Overlapping portions of feathers and light-colored feathers were often spared (Figures 3 and 4).

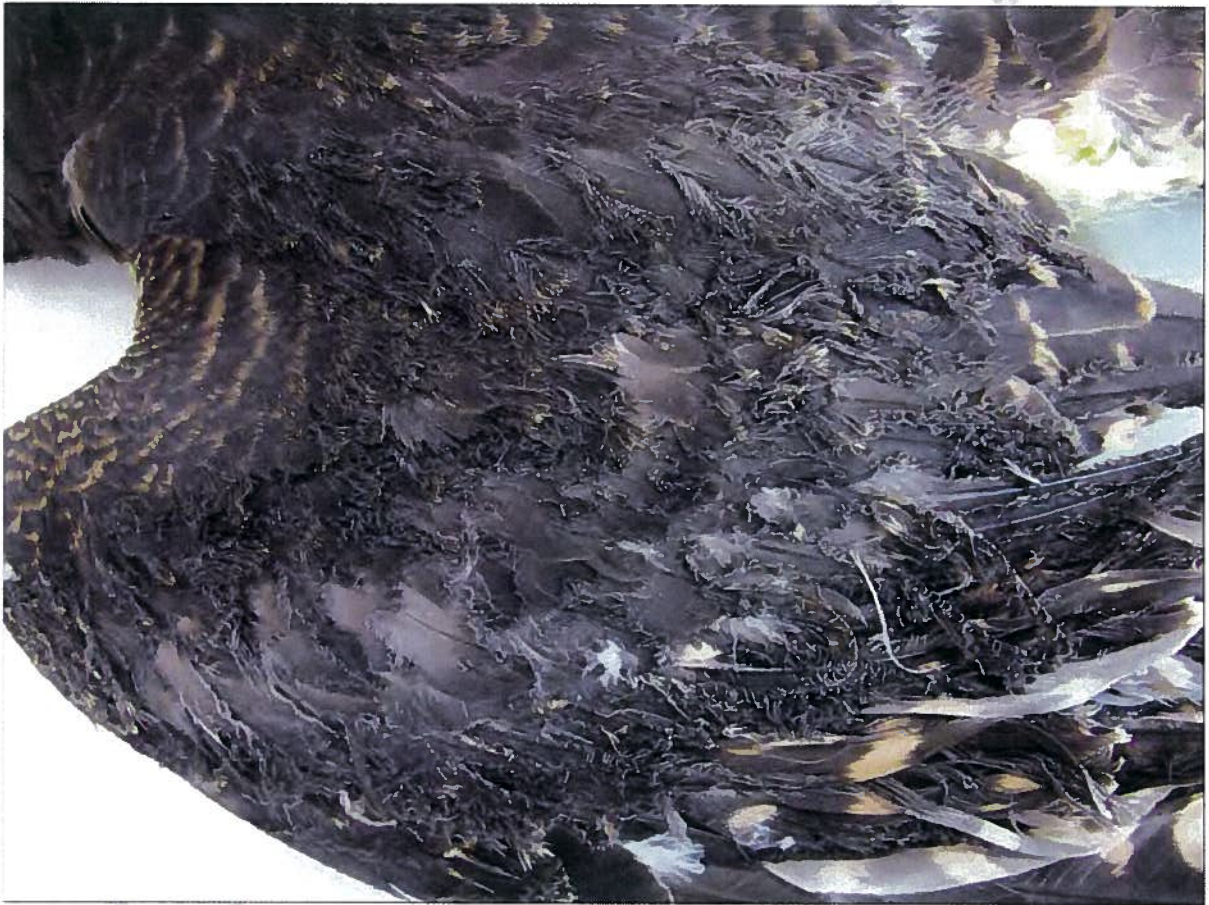
Figure 5: The dorsal aspect of the wing from a Peregrine Falcon (the same bird as shown in Figure 4) with Grade 2 lesions. Note extensive curling of feathers without visible charring. This bird was found alive, unable to fly, emaciated and died shortly thereafter. These findings demonstrate fatal loss of function due to solar flux exposure in the absence of skin or other soft tissue burns.

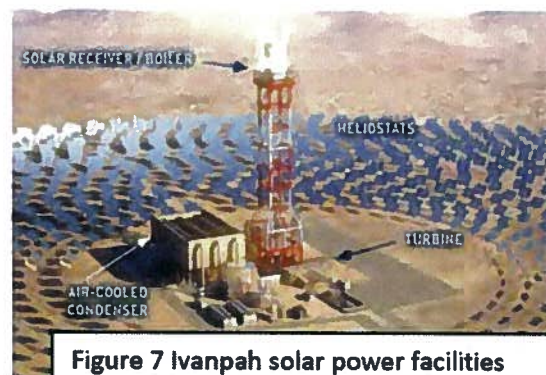
Figure 7 Ivanpah solar power facilities
<http://ivanpahsolar.com/about>

At the top of a 459 foot tall tower sits a boiler (solar receiver) that is heated by the sun rays reflected by 300,000 mirrors, called solar heliostats. When the concentrated sunlight strikes the boiler tubes, it heats the water to create superheated steam. The high temperature steam is then piped from the boiler to a turbine where electricity is generated (<http://ivanpahsolar.com/about> visited on 01/20/2014).

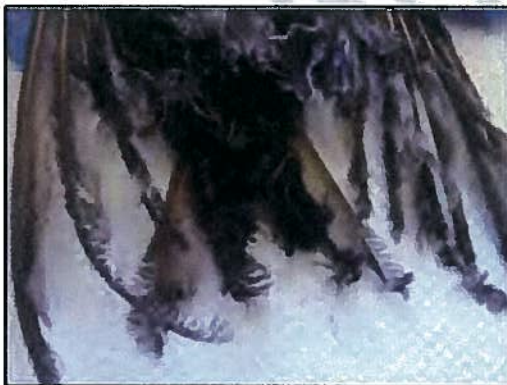
Many of the carcasses recovered from the Ivanpah Solar plant after the plant became operational showed singeing of feathers as shown in Figure 10.

Figure 10: Singed feathers from a Northern Rough-winged Swallow
